EUROPEAN PATENT APPLICATION

64 Member for indicating clogging of the air intake filter, particularly for motor vehicle engines.

EP 0 200 688 A1

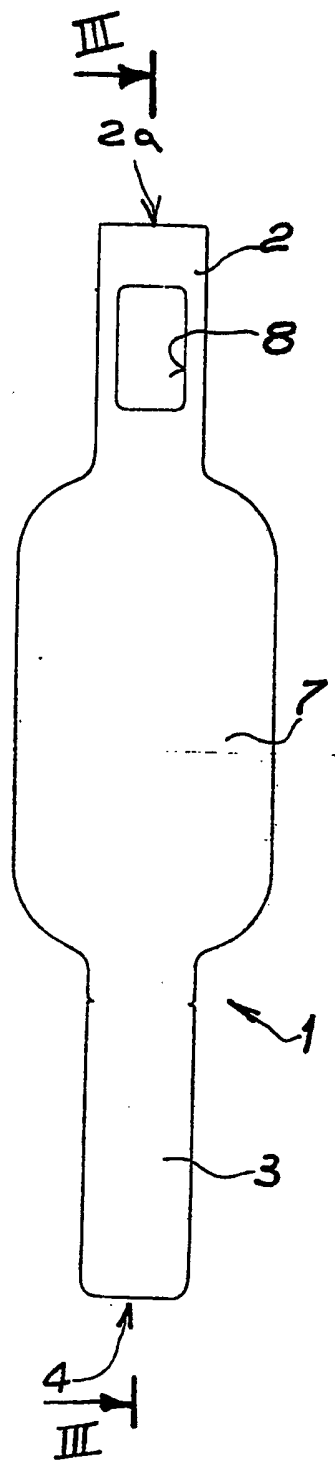
Fig. 1

Figure 1 is a plan view of the indicator member according to the
20 invention;

As can be seen from the figures, the indicator member according to the
30 invention consists of a duct 1 having an end portion 2 provided with an opening 2a to be located in communication with a zone external to the filter, and a tubular end portion 3 provided with an opening 4 communicating with the zone in which the air leaves the filter towards

A thin strip 6 of plastics material or the like is connected to this piston and extends through the intermediate portion 7 of the duct 1 as 10 far as the end portion 2. In proximity to the opening 2a of said end there is an aperture 8, through which the end part of the strip 6 can be seen.

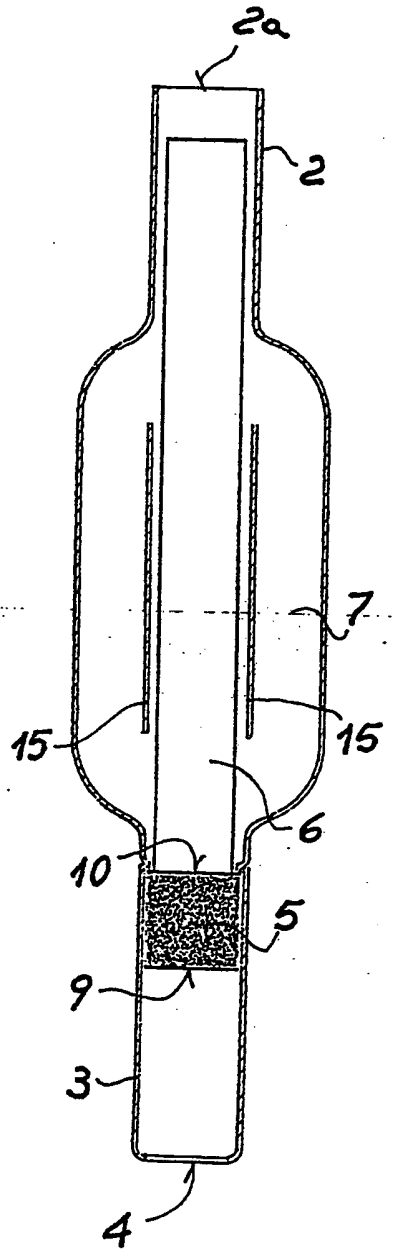
Fig. 2

Figure 2 shows the indicator member of Figure 1 without its upper part;

In the tubular end portion 3 there is disposed a piston 5 of light material such as expanded closed-cell material, which can slide within 5 the tubular portion 3 under the action of a slight pressure difference between the two parts of the tubular portion 3 separated by it.

Guide baffles 15 are conveniently provided in the intermediate portion 7 to help maintain the strip 6 aligned with the piston 5 connected to it, and to also provide rigidity to the portion 7 zone which is to be compressed for deforming said gaskets.

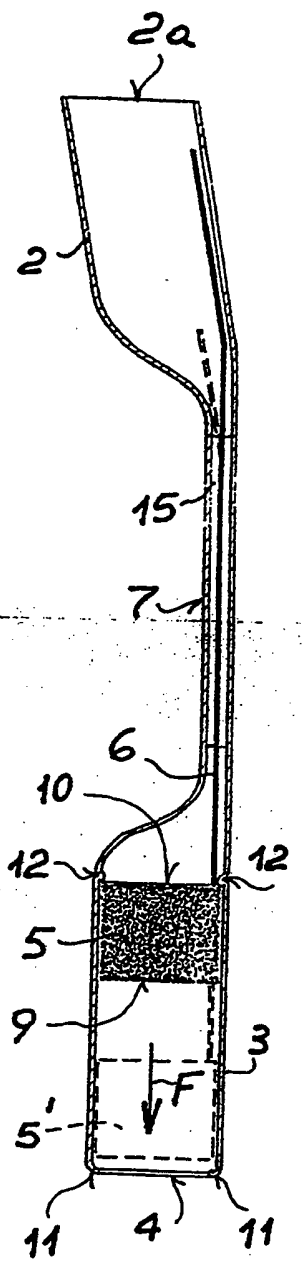
Fig. 3

Figure 3 is a section on the plane III-III of Figure 1; and
25

When the filter is clogged, the air drawn in by the engine undergoes a 20 large pressure drop in passing through the filter, and this results in a vacuum at the filter outlet in the direction of the engine. This vacuum also acts on the face 9 of the piston 5 which faces the end portion 3, whereas the pressure of the external environment acts on that face 10 of the piston which is in communication with the outside by way of the 25 intermediate portion 7 and the end portion 2 of the duct 1. Under these conditions, the piston thus moves in the direction indicated by the arrow F of Figure 3 to the position indicated by 5', in contact with the rim 11 at the opening 4 of the tubular end portion 3. The strip 6 is therefore no longer visible through the aperture 8, and this therefore 30 signals that the filter is clogged and requires replacement or cleaning.

When the filter has been replaced or cleaned, the piston 5 can be again moved into its initial position, indicated by the stop projections 12

provided internally on the end portion 3 in the position in which the end of the strip 6 is visible through the aperture 8.

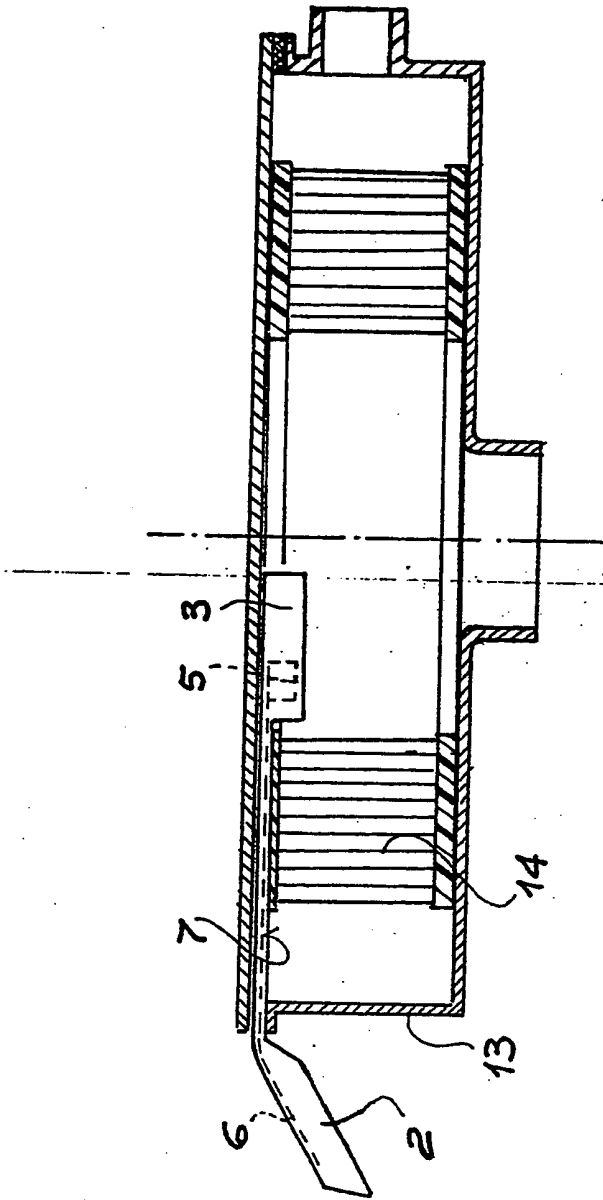
Fig. 4

Figure 4 is a diagrammatic section through a filter provided with the indicator member according to the invention.

As can be seen in Figure 4, the indicator member according to the invention can be mounted in a filter casing 13, and disposed with its intermediate portion 7 over the annular filter 14. The tubular portion 3 thus lies in the inner zone of the filter, in communication with the engine intake duct, and the end portion 2 lies external to the casing 13, enabling the aperture 8 to be seen without dismantling the filter casing.

This is attained by a slight deformation of the seal gaskets of the casing 13 and filter 14, the intermediate portion 7 being constructed with a very small thickness, which is less than the deformability of said gaskets.

The intermediate portion 7 is wider than the remaining parts of the duct 1, to provide in the zone corresponding with said small thickness an intake air passage area large enough to give sufficient indication sensitivity by limiting the pressure drop.
